BUILDING CONDITION AND PROPOSALS REPORT

BATH HOUSE BUILDING PRESTONGRANGE INDUSTRIAL HERITAGE MUSEUM PRESTONPANS

August 2010

Prepared for:
The Battle of Prestonpans Heritage Trust

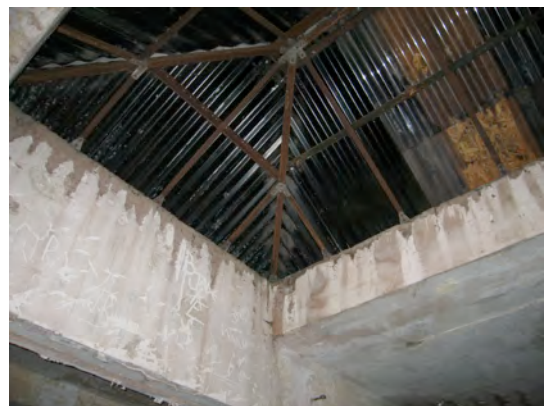
Steel framed roof lantern

Roof glazing	Several substantial roof lanterns built off concrete structure using steel framework with galvanised corrugated steel covering and translucent corrugated sheet glazing.	Fair to poor condition with localised damage to corrugated sheeting and to translucent materials. Poor upstands throughout and poor decorative order to steel structure.	Consider replacement throughout of corrugated sheeting using new sheet material or alternative double glazed patent glazing system. Consider alternative of installation of new upper glazing over existing lanterns if lightweight over-roof is to be constructed.	2	
Roof parapet	Brick parapet throughout rising above mastic asphalt roof with precast concrete copes and reinforced mastic asphalt upstands.	Copes generally in fair condition with some dislodged copes and evidence of poor pointing throughout. Mastic asphalt upstand flashings extremely poor.	Remove existing copes, provide flashing beneath and rebed existing copes throughout with new pointing. Provide for replacement flashings or gutter detail around perimeter of roof using material appropriate for final selection of roof covering.	1-2 2

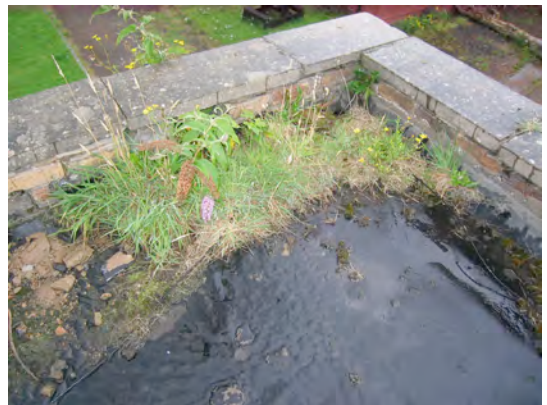
Detail of roof showing failure of asphalt and cope

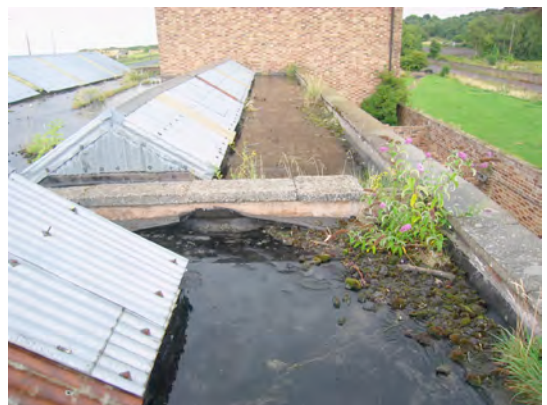
Failing copes, upstand and deck to main roof

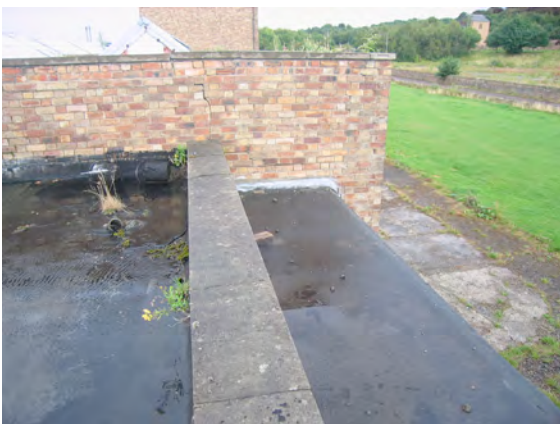
West canopy roof and crack to brickwork
