CONDITION AND PROPOSALS REPORT

PRESTONPANS TOWN HALL

January 2010

BUILDING CONDITION AND PROPOSALS REPORT

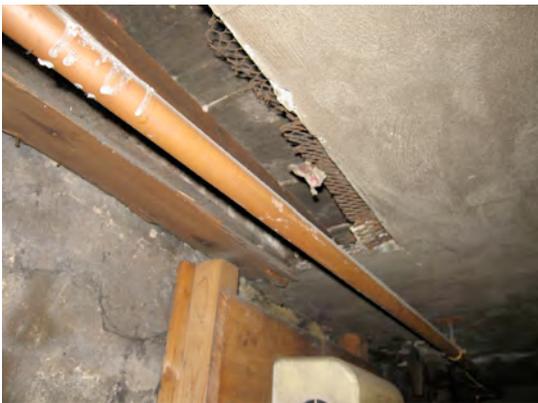
Damaged plaster to basement ceiling

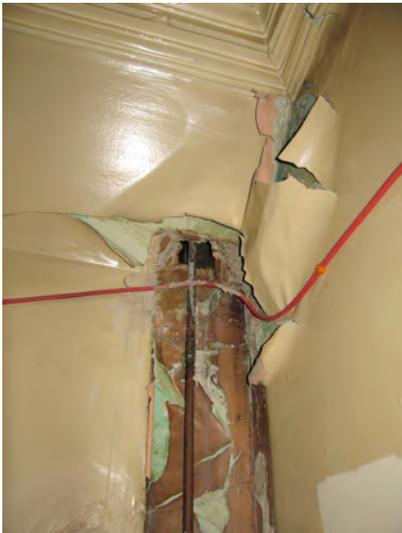
- 6.17** The **internal plasterwork** is in reasonable condition although there is minor damage and wear and tear. The plasterwork above the suspended ceilings has been badly damaged, locally, by the suspension cables and insertion of pipework and wiring. The timber ceiling to the hall could not be fully inspected but appeared to be in fair condition.

Ceiling void over ante room
showing typical damage at services

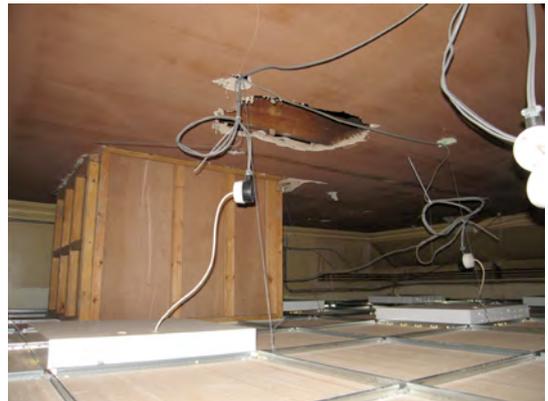
Ceiling void over ante room
showing damage to upper ceiling

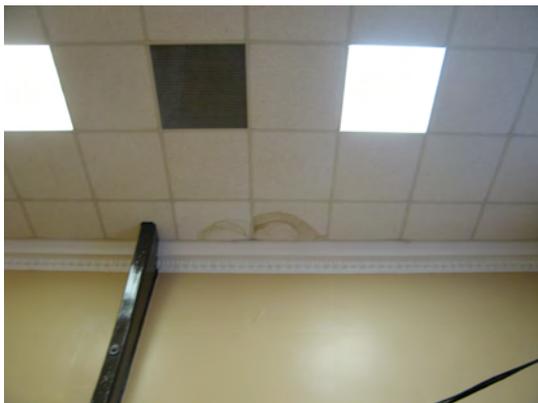
Water damage to hall ceiling, West side

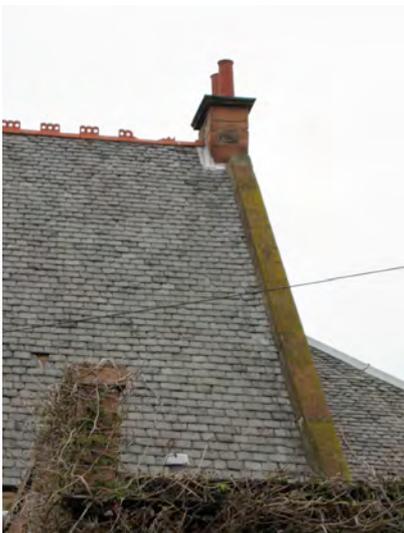
- 6.8 The **west chimney** is in fair condition but the pointing is failing and the cope missing.
- 6.9 The **south chimney** is in very poor condition and the cope has very wide open joints, resulting from frost damage allied to separation in the masonry below.

Detail of SW skew, ridge and S chimney

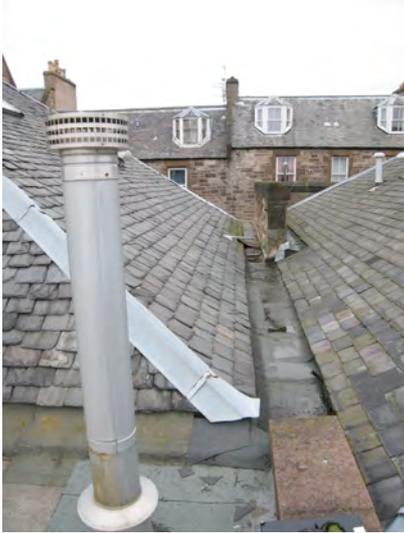
- 6.7 The **roof edge** detailing, at skews, abutments ridges, chimneys and eaves is poor, particularly where cement fillets are damaged and mineral felt has been used. The mineral felt gutters and weatherings to the south and west elevations are relatively recent but are inappropriate and likely to require replacement in the short to medium term.

Felt valley gutter to S and boiler flue

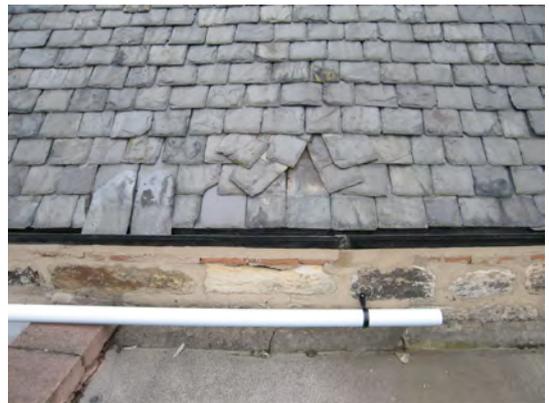
Detail W pitch eaves showing slate work, masonry decay, rhone and plastic rainwater pipe

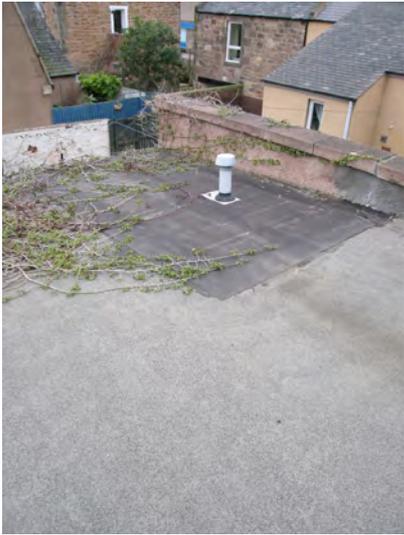
Landing roof looking NW
showing felt patch to mastic
and vegetation

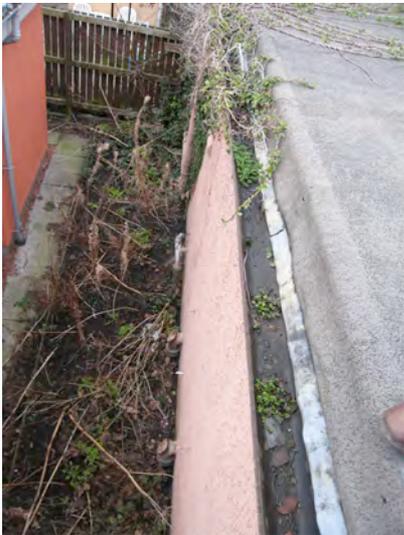
- 6.21** There are no **external paved surfaces**, except the public pavements to High Street and New Street. The ground to the immediate west is in separate ownership but Ivy and Brambles are spreading into the hall rhones and over the roof. The High Street stone front door steps are in poor condition.

West low level eaves showing
blocked rhone and vegetation

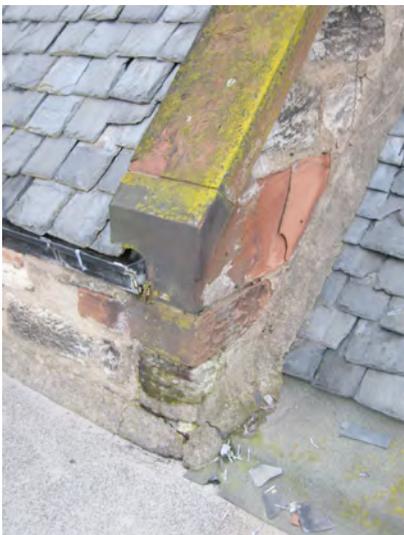
Detail of SW skew and gable
showing poor fillets and flashings
and masonry decay

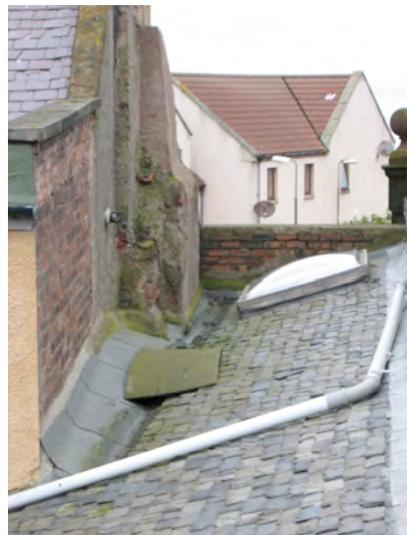
Detail of abutment to NW showing
rooflight, rainwater pipe and felt
weatherings and gutter at abutment

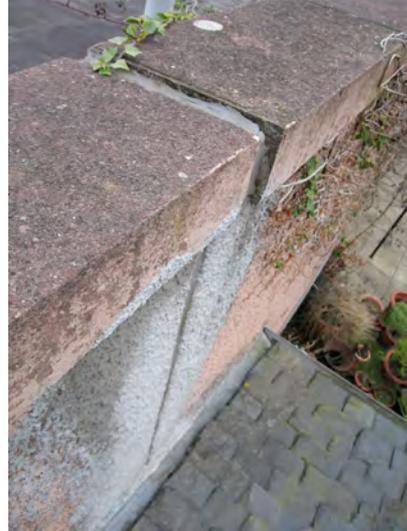
- 6.12 There is a **significant crack** in the internal partition wall and parapet above the bar area and upper landing, which has been repaired but has reopened. The cope is exposed and likely to be leaking.

Detail of crack to wall and parapet cope to mastic roof

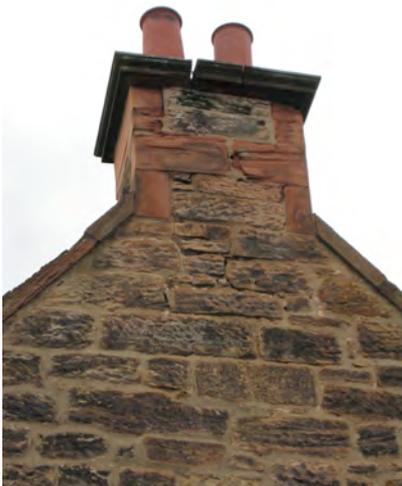
Detail of chimney showing movement to chimney and cope

Chimneys	Single two flue gable stack to South hall gable with stone cope, 2no terracotta cans and ashlar dressings.	Poor condition with serious cracking to cope and evidence that chimney is spreading at head. Pointing generally poor.	Carefully dismantle stack and provide for rebuilding with new stainless steel ties to copes. Provide for renewal of 50% of existing masonry and reuse of existing copes. Replace chimney cans with new haunching and fit ventilating terminals.	1	4860
Rainwater goods	Single plastic hopper and downpipe to corner with adjacent building to South.	Fair condition.	Replace hopper and downpipe as part of works to renew valley gutter using cast iron.	3	540
Walls	Coursed sandstone rubble gable wall at high level with cement pointing and red sandstone ashlar skews.	Fair/poor condition with inappropriate pointing and extensive evidence of open joints to skew stones and at high level to stack.	Provide for picking and pointing 100% including removal of skews and rebedding on lime mortar with new mortar pointing between. Provide for replacement of 1no skew stone entirely. Provide for indent removal repairs to 1m2 approximately.	2	3460

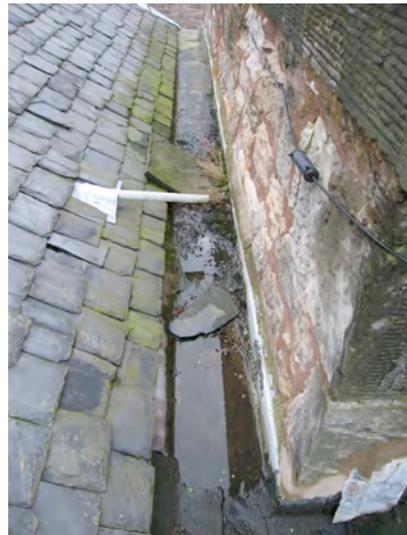
Detail of S roof felt gutter
