CONDITION AND PROPOSALS REPORT

PRESTONPANS TOWN HALL

January 2010

BUILDING CONDITION AND PROPOSALS REPORT

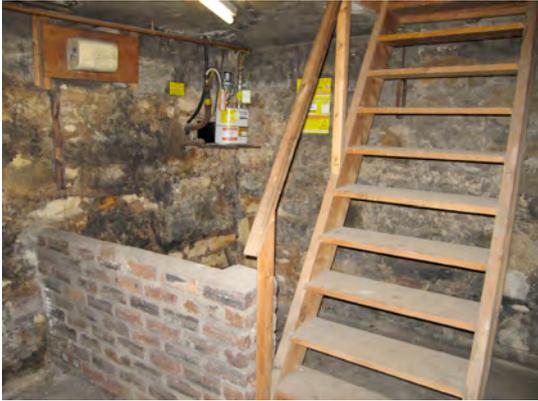
Basement looking NE, showing stair and gas meter

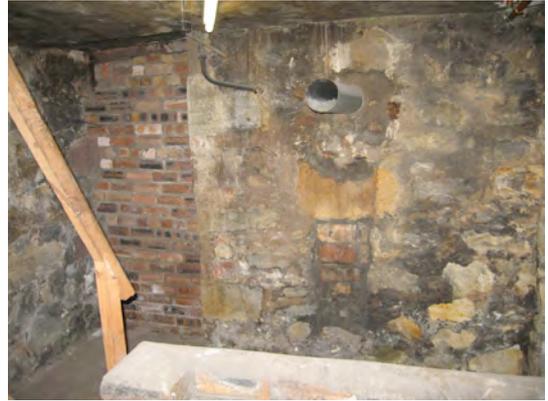
Basement looking SW, showing blocked door and open flue

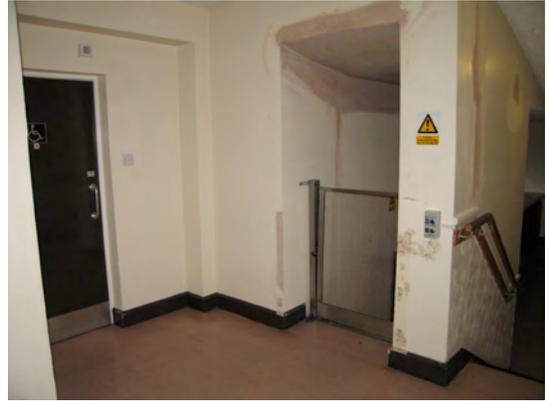
Landing and access platform lift

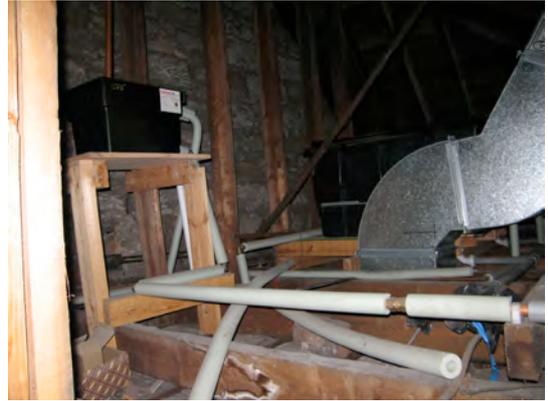
Roof space over kitchen showing extract

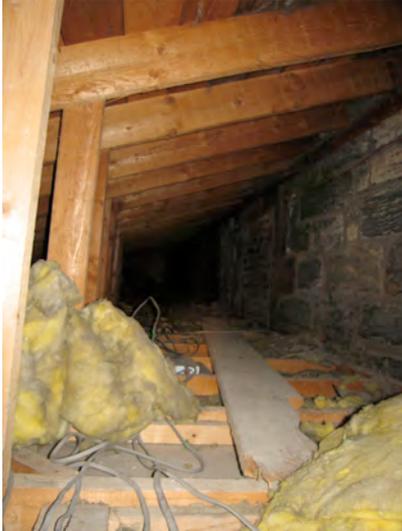
Roof space over bar showing
blocked windows

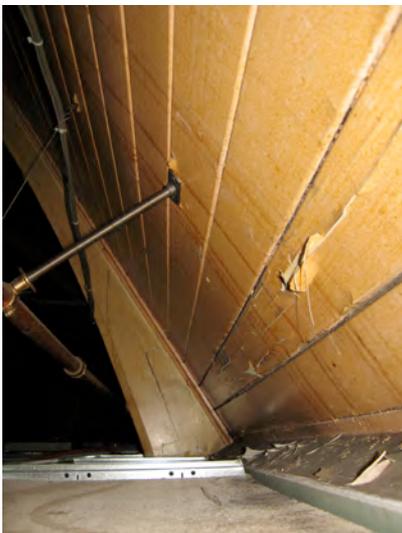
Detail of hall upper ceiling
and roof truss

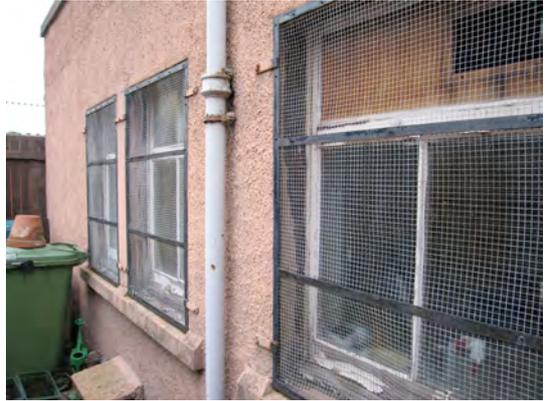
Windows to caretaker's store and ladies toilet on S elevation

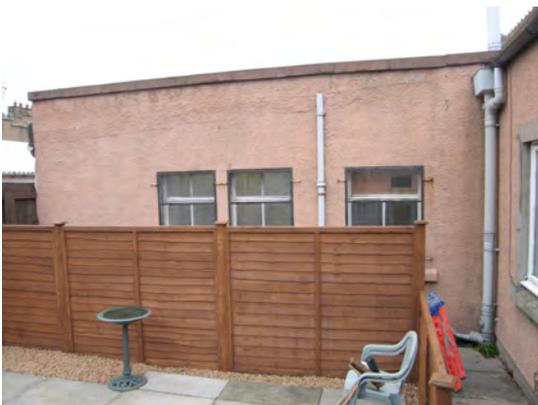
S elevation

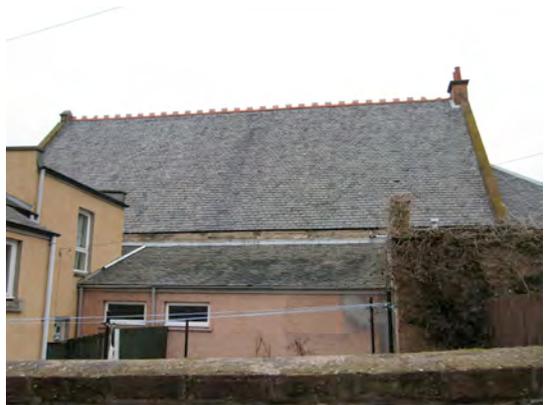
W elevation (part) and roofs

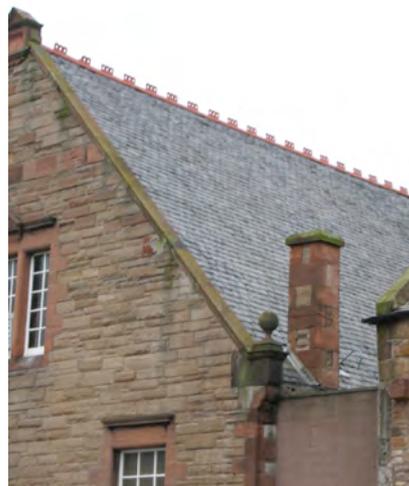
Detail of NW skew and chimney

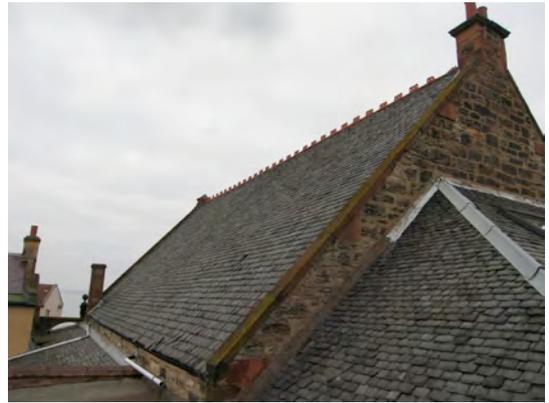
View of roofs looking NE

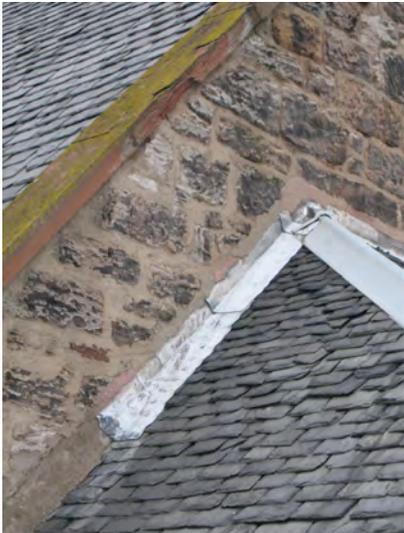
Detail of abutment to roof at N gable

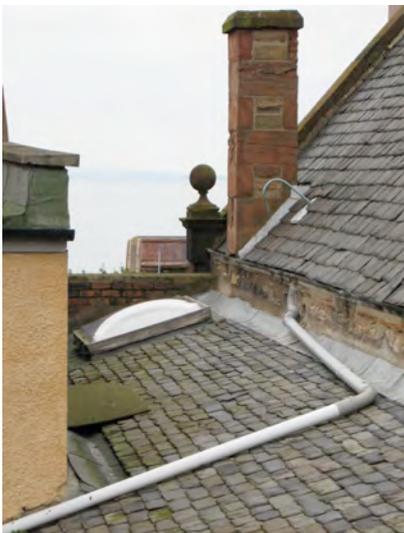
Detail of N lobby roof showing rooflight

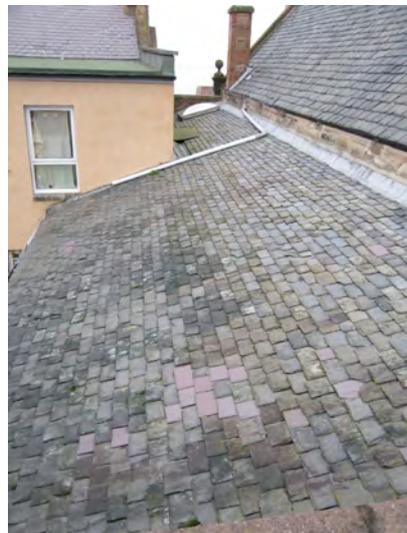
Bar area roof looking W

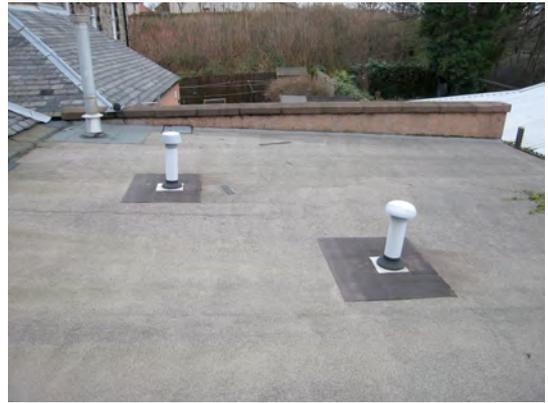
Landing roof looking S, showing
ventilation terminals and flue

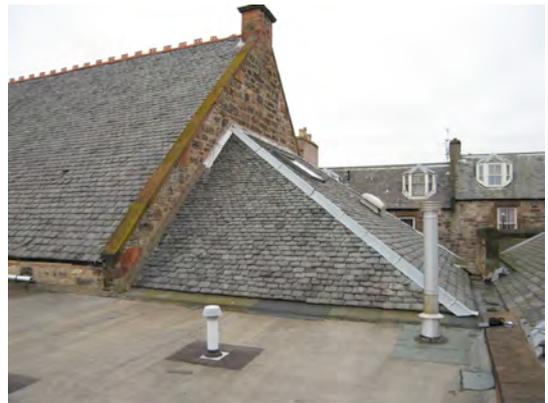
View of roofs looking WNW

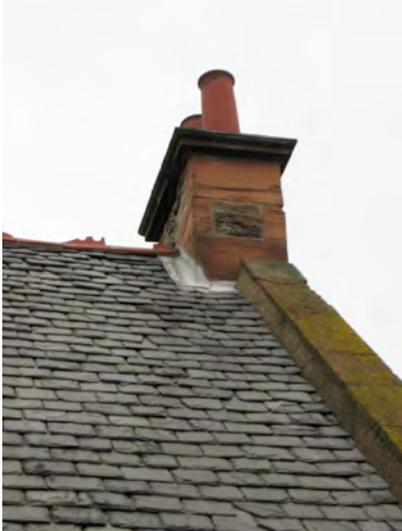
Detail of N gable chimney
